This final report presents the results of field monitoring and describes remedial measures to improve stability through the spring of 1980.

REPORT NO. FHWA/CA/TL - 80/27

LONG-TERM PERFORMANCE OF THE FIRST REINFORCED EARTH WALL IN CALIFORNIA

**FINAL REPORT
AUG, 1980**

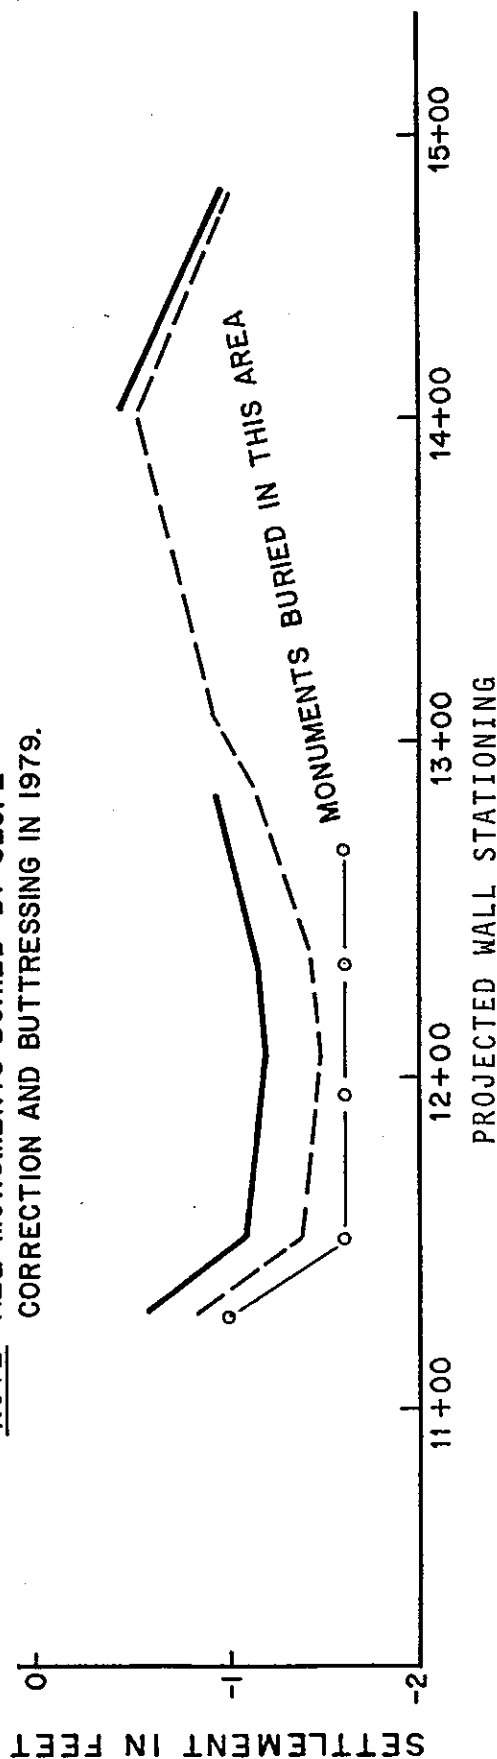
FIGURE 12

SETTLEMENTS AT SERIES "A" MONUMENTS

Settlement of the wall has continued since construction. A total settlement of 3.5 ft was recorded on settlement platforms SP1 through SP4 at Sta. 551+75, Level A, through December 1973. (Refer to Figure 8.) The readout at this level was destroyed after that date. Measurements on Series "A" and "C" monuments have provided a continuation of the settlement record. Based on these measurements, about 1.0 ft of additional settlement has occurred through May 1980. Measurements on Series "A" monuments show a maximum of 0.5 ft of settlement between 1973 and 1978 (Figure 12). No settlement measurements are available for Series "A" monuments after 1978 since they were buried by the correctional work. Series "C" monuments at the top of the wall suggest a maximum of 1.0 ft of settlement between 1973 and May 1980 (Figure 13). About 20% of that occurred since 1978.

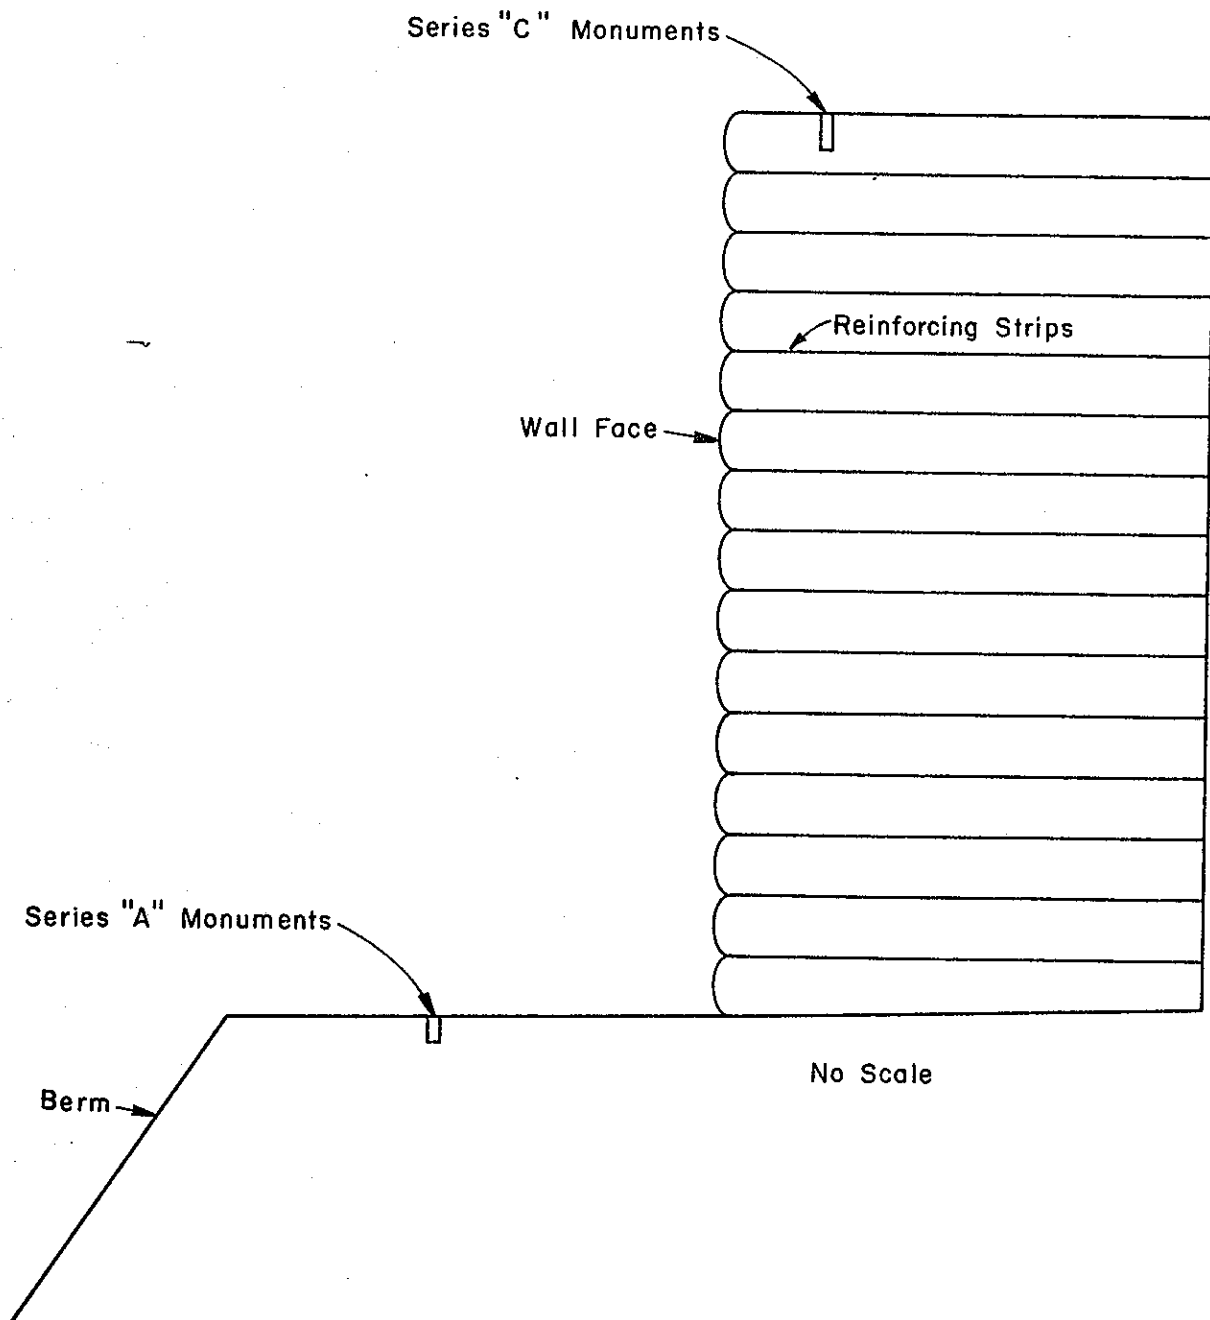
FIGURE 9

Most of the surface monuments on top of the wall were located and surveyed by District 07 Survey personnel. Destroyed monuments on top of the wall and on the new toe buttress at the base of the wall require reestablishment to monitor long term performance. The approximate location of these monuments are shown in Figure 9.

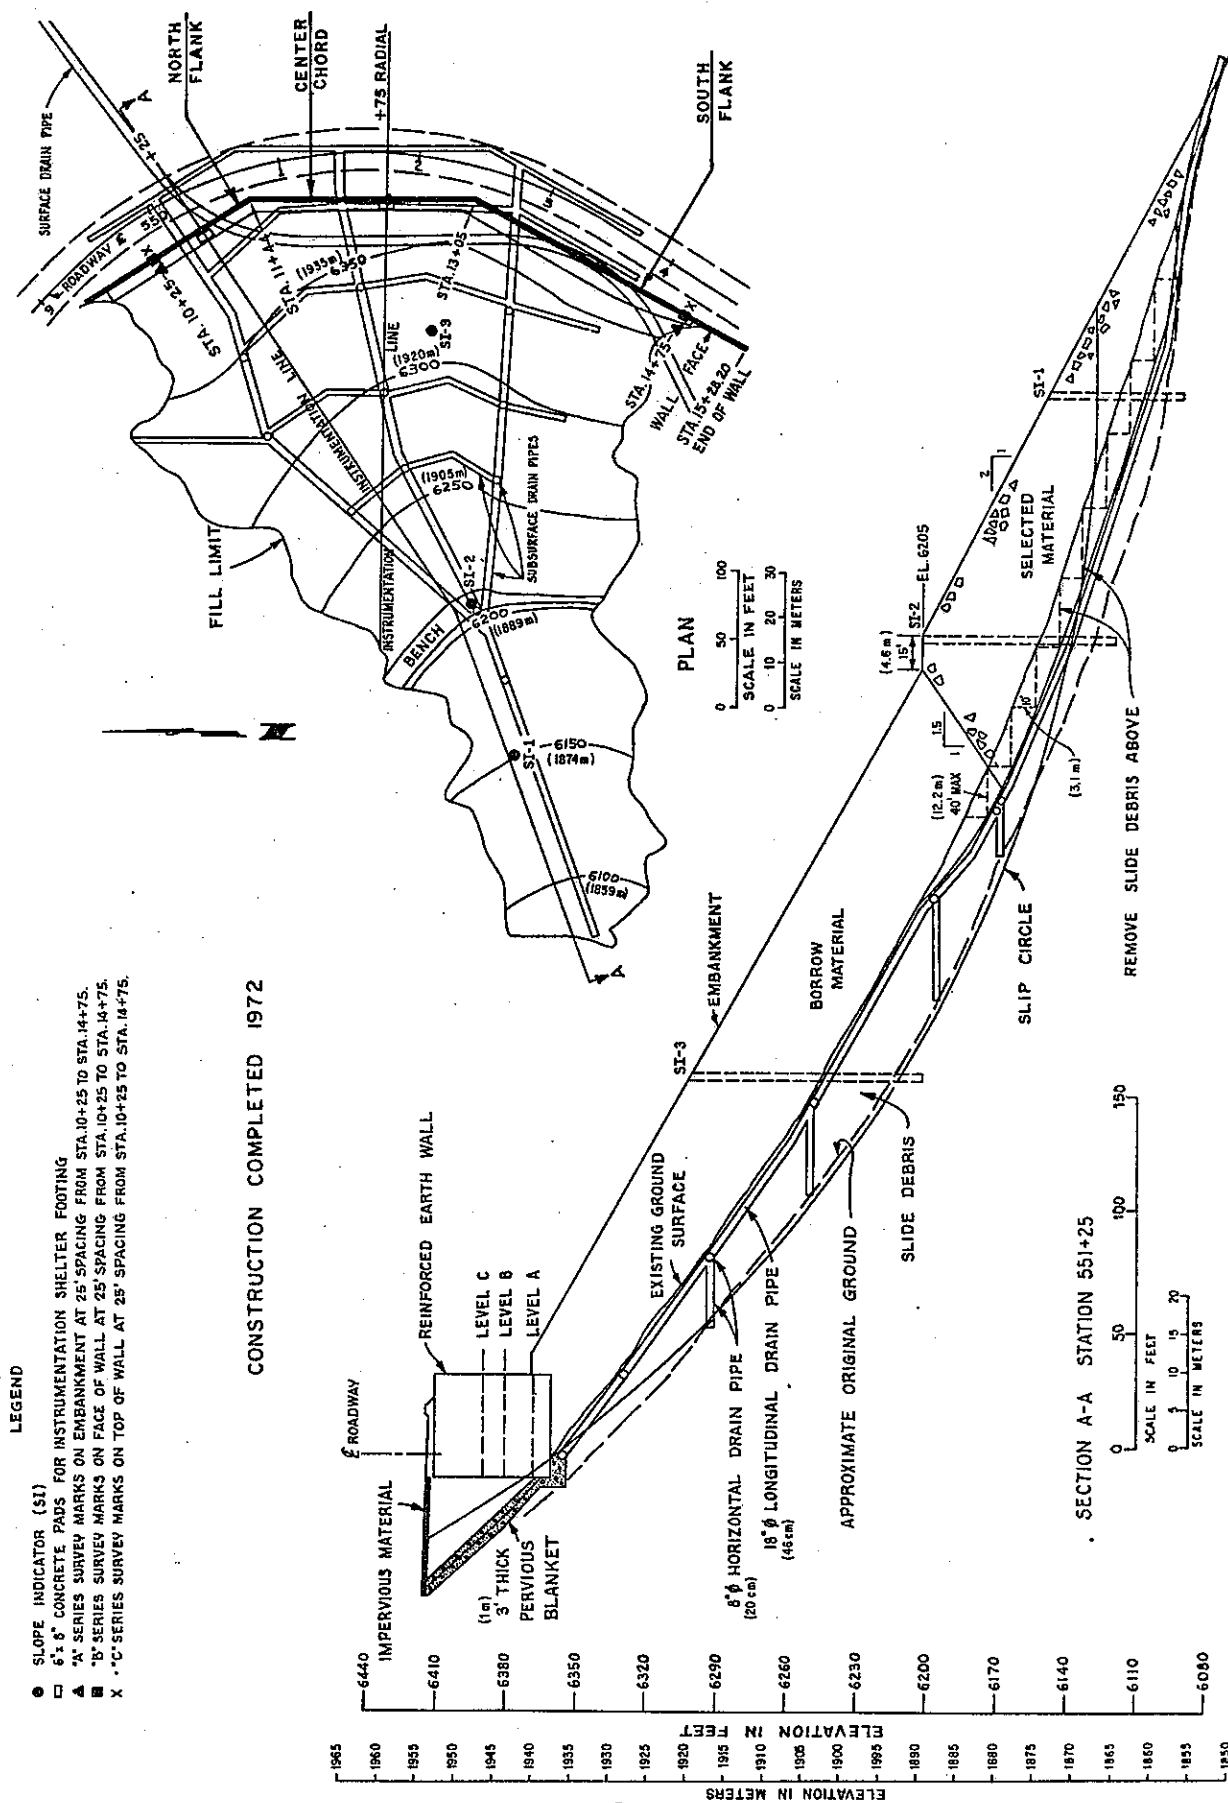
FIGURE 1

Slope indicator locations SI-1 through SI-3 (Figure 1) were buried by slide debris during the winter of 1976-1977. Attempts to relocate these installations were unsuccessful. Since measurements prior to 1977 did not indicate a deep seated movement, the installation of replacements was considered to be unnecessary. It was, therefore, decided to utilize the Series "A" and "C" surface monuments and strain gage readings to detect additional movement.

personnel below the pavement surface near the south flank of the wall above the pervious sand blanket behind the reinforced earth wall. (See Figure 1 Profile.) Maintenance forces were requested to identify the extent of the cavity and backfill it with either pea gravel or jetted sand. This would be followed by sealing the roadway surface with asphalt concrete to prevent infiltration of surface water. Maintenance elected to jetty sand into the cavity, which on observation appeared to provide a satisfactory repair. A similar crack was repaired in the same area during the spring of 1973.
